Fire Restoration in East Sussex

CASE STUDY

East Sussex, United Kingdom

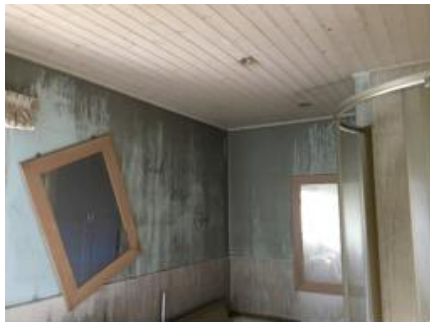
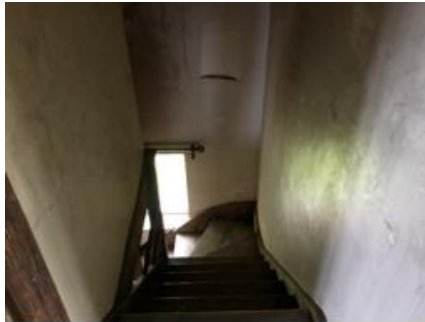
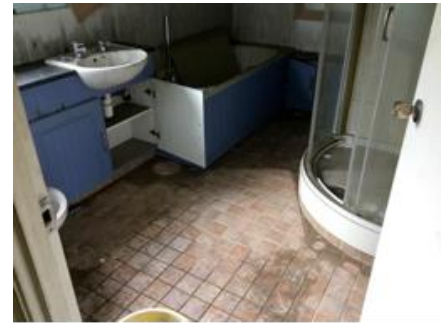
The remaining rooms in the property required decontamination and cleaning, including the kitchen which suffered from severe fire damage.
