Fungal Remediation in Kent

CASE STUDY

Fungal Growth in Kent

We were called to a semi-detached property in Folkestone, Kent, that was built circa 18th century and was suffering from extensive fungal growth. The three-storey property has been turned into flats, and it was the basement flat that we were called to look at.

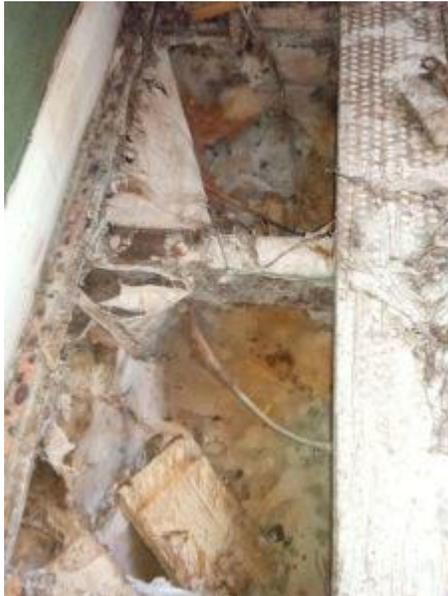
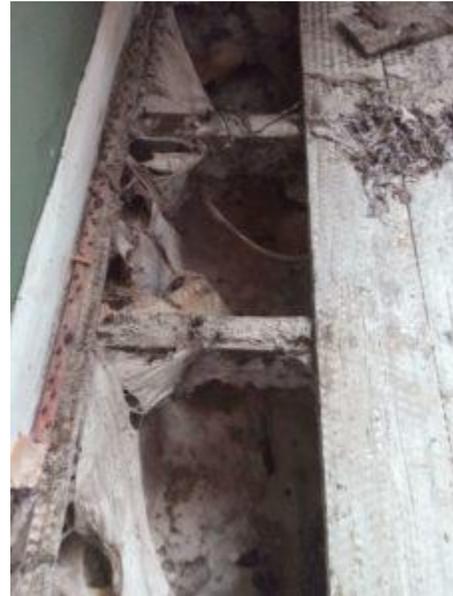
Following investigations from another company, fungal growth was found to be growing under the floorboards in the lounge area. We attended site to assess the damage to the structure of the building caused by the fungi and investigate the cause.

When we arrived on site, we were shown the damaged timber floorboards along with the wooden joists and base plate along the external wall. The damage was very extensive and all the affected woodwork needed complete removal.

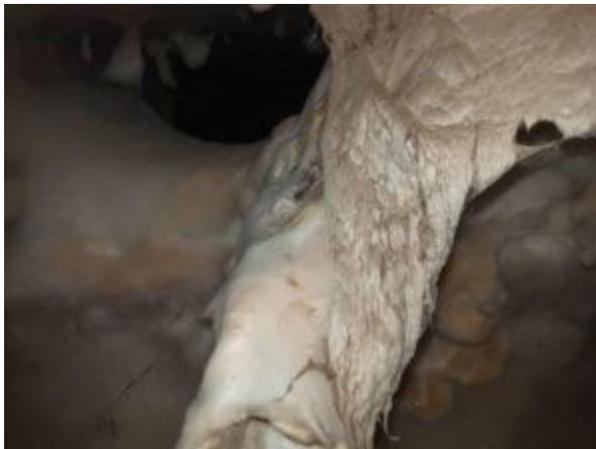
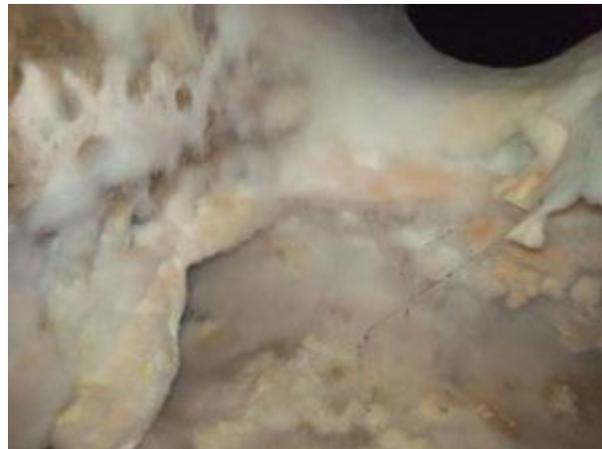
The basement flat has solid brick walls finished with plaster, and a suspended timber floor with a variety of floor coverings installed on top. When we visited site, we wanted to investigate the DPC (damp proof course) in between the joist's supporting base plate and the brickwork beneath. However, due to the amount of fungal growth underneath the floor, this wasn't possible.

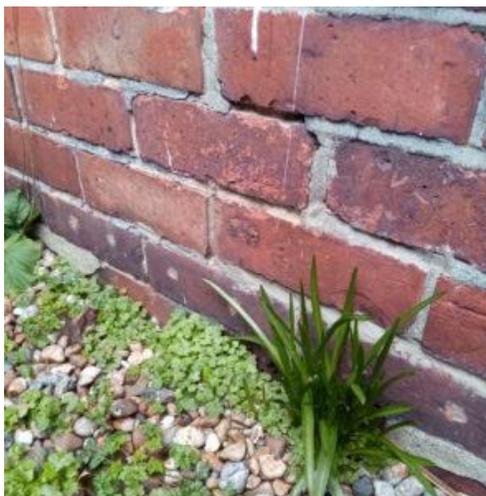
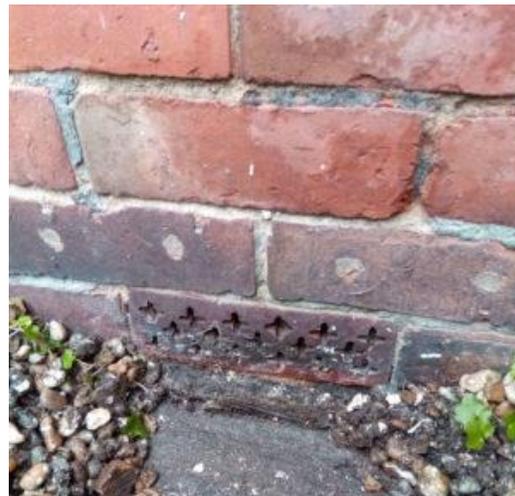
According to NHBC standards and building regulations, air bricks should be located at least 75mm above hard and soft landscaped areas to reduce the risk of being obstructed or flooded.

Air bricks may be located at or near ground level where measures have been taken to avoid flooding by sloping the ground away from the air brick and providing drainage where the ground is not free draining.

In this case, both air bricks located at the front of the property are exposed to flooding, and both of them have been obstructed preventing ventilation of the subfloor void. It is very likely that this may have contributed to the damp issue and fungal growth inside the property.

As visible in the photos above, the lower bricks of the property have had chemical DPC (damp proof course) injected at some point in the past. This indicates that there is/was an issue (possibly breach or bridging) with the original DPC, hence why a chemical DPC was injected into the masonry.

- The leaking guttering should be inspected and repaired accordingly.
- The air bricks need to be cleaned and kept clear – ideally, the ground level of the front patio should be lowered to reduce the chance of the subfloor being flooded by rainwater.
- DPC to be inspected once the fungal remediation has been completed.

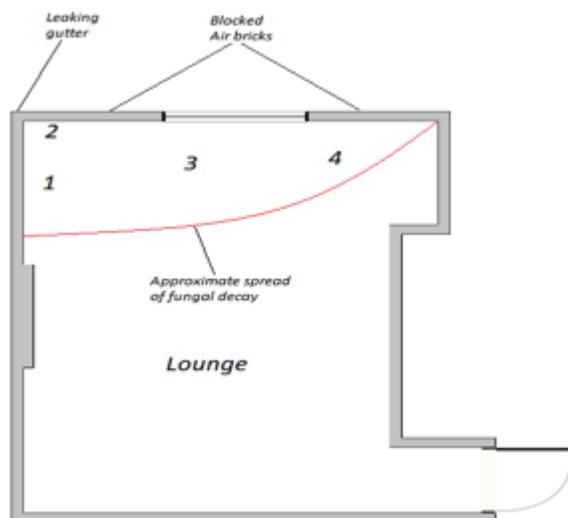
We identified biological growth on the masonry along the guttering and downpipe. This indicates that there may be a leak from the gutter above, which may also be contributing to the issues inside the property.

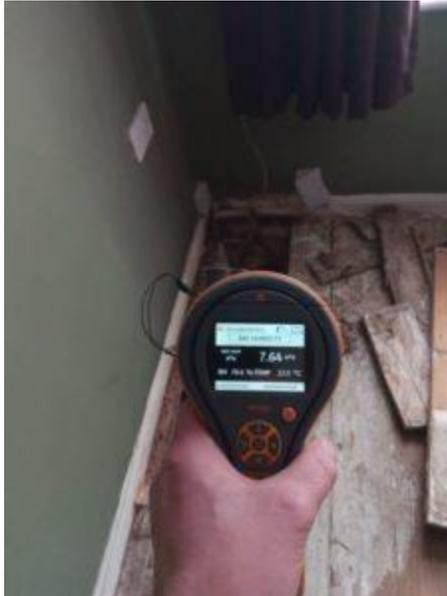
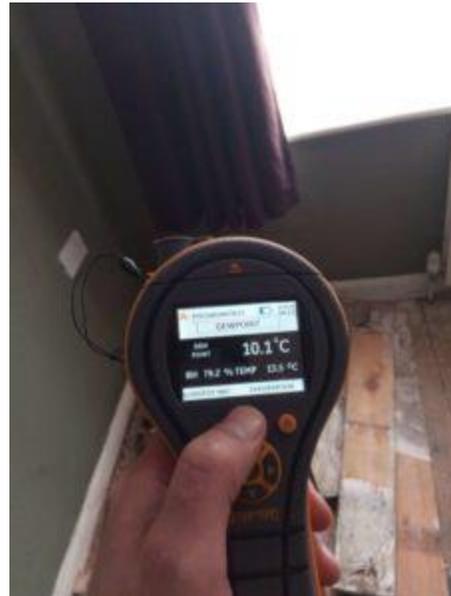
During our inspection, we carried out a moisture survey which found that the moisture content of the timber floorboards was very high, especially around sample points 1 and 2. It gradually decreased as we moved towards sample point 4, indicating that the primary source of the moisture may be located on the left-hand side of the external wall.

Upon completion of our inspection and moisture survey, we concluded that the building issues identified above caused the fungal growth in the lounge area of the basement flat in Folkestone.
