Water Damage Cleaning, Residential Property in London

CASE STUDY

North London, United Kingdom

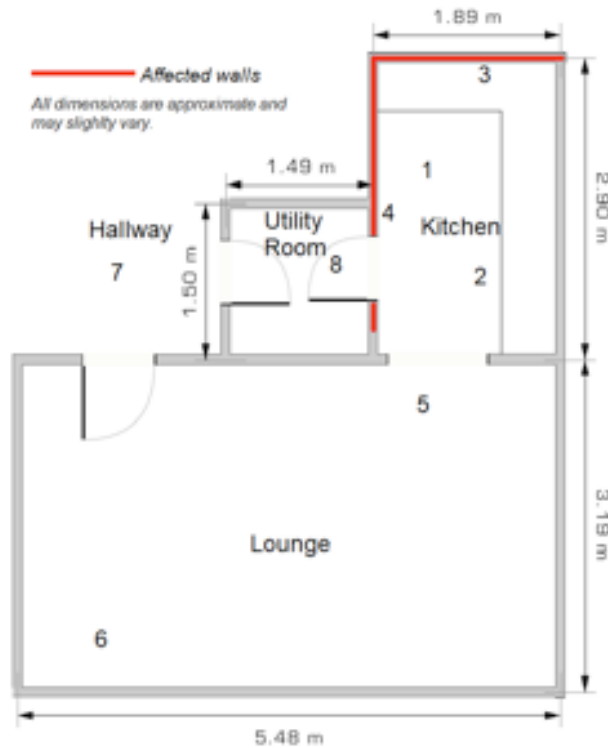
The kitchen floor and lower plasterboard walls recorded at 999 REL in all tested locations. We also recorded increased moisture readings of up to 450 REL on the wooden flooring in the lounge adjacent to the kitchen, compared to readings of 160-170 REL on the opposite side of the lounge and hallway.

As a result of high moisture levels within the floor and lower walls, mould growth had started to appear. We also noticed salt residues on much of the kitchen floor, indicating high moisture levels below.

- The uplift of the kitchen floor tiles.
- The removal of kitchen tile adhesive.
- The removal of kitchen skirting boards.
- The creation of an inspection hole within the kitchen floor to confirm its construction.
- The installation of drying equipment to the kitchen.
- The installation of a temporary floor to minimise disturbance and remove potential tripping hazards.
