Water Damage and Drying in East London

CASE STUDY

East London, United Kingdom

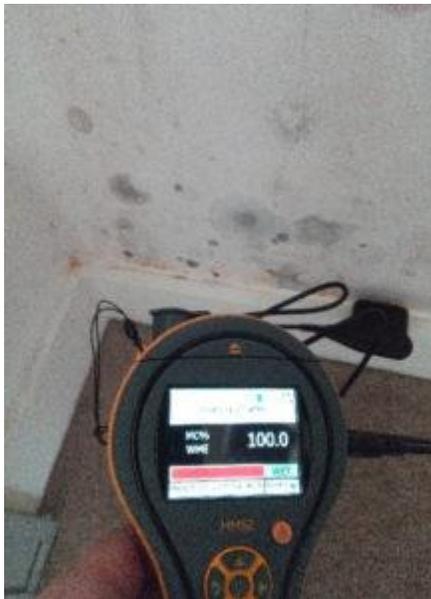
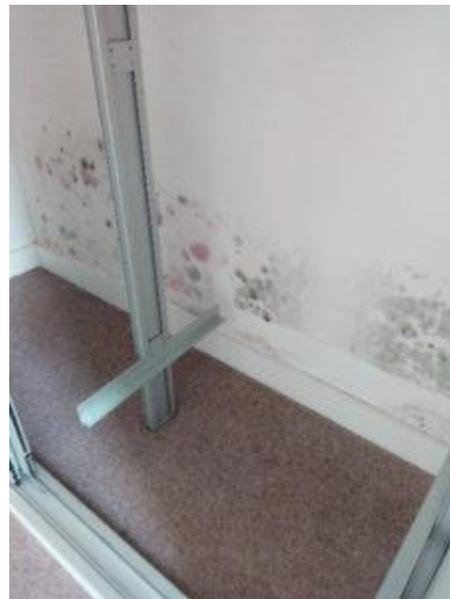
Upon our inspection, we found mould growth forming on the surface of the bedroom party wall dividing flat 311 (the affected property) and the neighbouring flat 309. Standing water was also discovered within the cavity of this wall. The wall cavity in the bathroom was also contaminated with mould.

Due to the construction of the floor, the only alternative to extensive strip out work (the partition walls were built on top of the chipboard floor), was to carry out specialist drying in the form of pressure drying to the affected areas. By using pressure drying, we were also able to target the damp plasterboard ceiling in the flat below.

The entire property also required ULV fogging using an antimicrobial solution. This was done before and after the drying was complete.

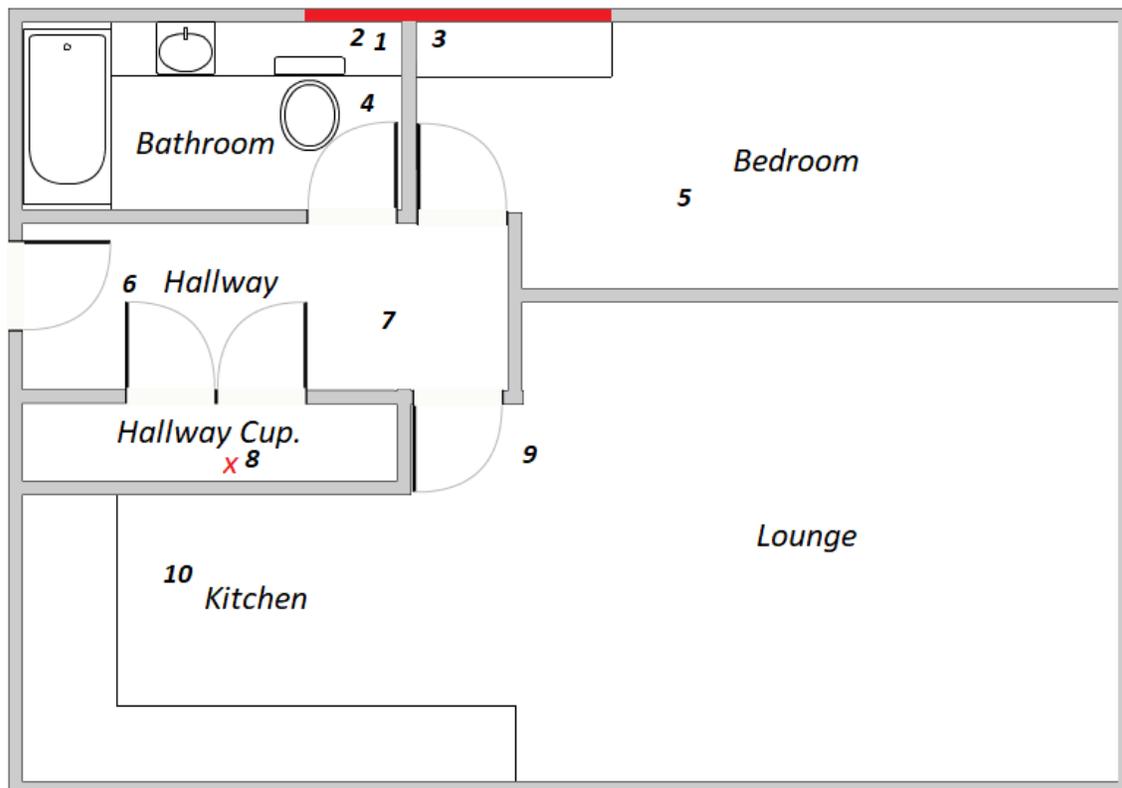
x - location of the leak

■ - affected wall

At the time of our visit, the only areas that registered as damp were a section of the party wall, separating flats 311 and 309, and a section of the concrete floor and chipboard behind the bathtub in the bathroom.
