# Cygnets Hospital Coronavirus Decontamination

CASE STUDY

Covid-19 decontamination allows safe return of patients.

3-stage emergency process returns wards to normality.

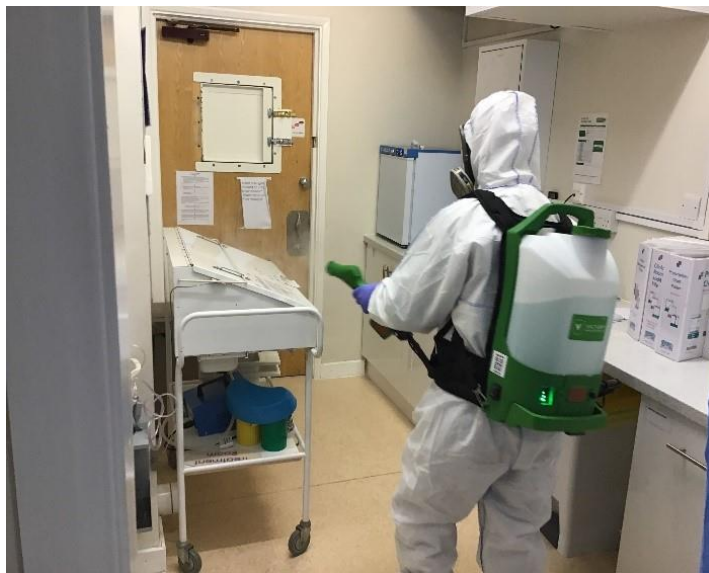
Electrostatic backpack sprayers and an air decontamination unit – which releases ultra-sterilised air into contaminated areas.

Our team carried out Adenosine Triphosphate (ATP) testing – a method widely used to test the cleanliness of a surface), before completing the first stage of disinfection in full PPE. The team used electrostatic backpack sprayers, which deliver a precise application to end bacterial, viral and pathogenic contamination. To reduce cross contamination, the team also sprayed themselves down when exiting different areas of the contaminated zone.

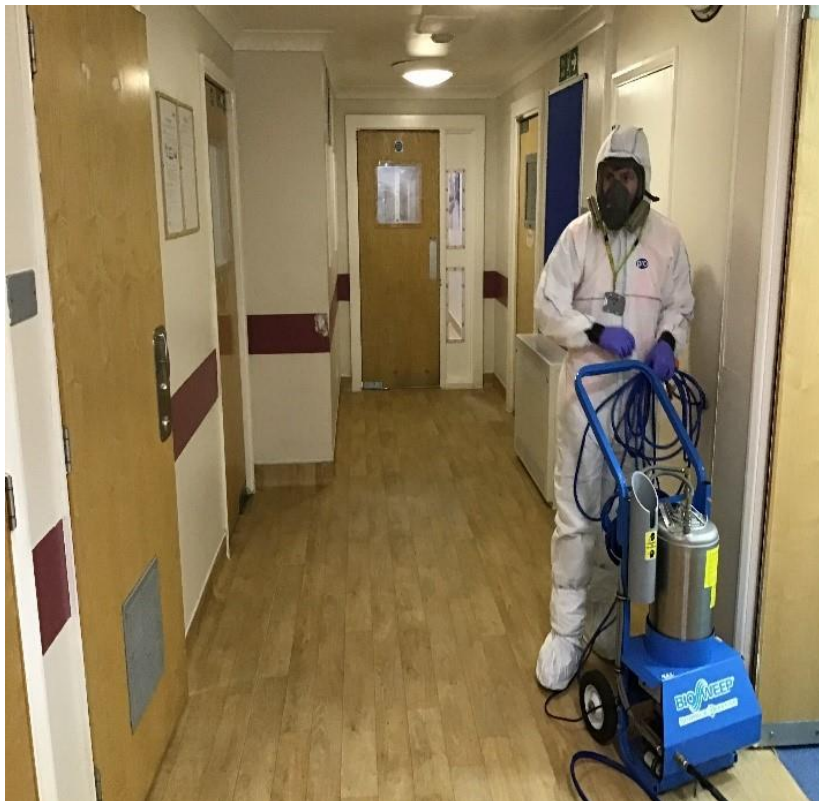
Air decontamination was also a major element of the decontamination process.

The Ideal Response team cycled air within the treatment area for several hours, using delivery units with High-Efficiency Particulate Air (HEPA) filters. This eradicates odours, bacteria, viruses, Volatile Organic Compounds (VOCs) and suppresses mould spores.

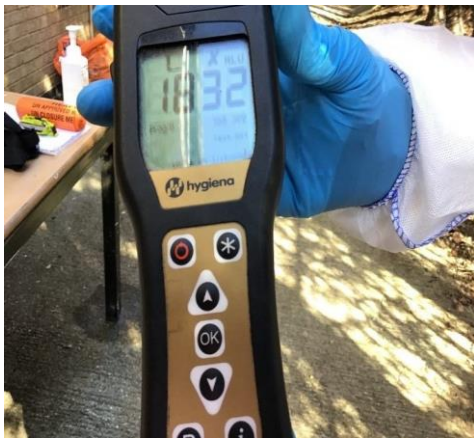
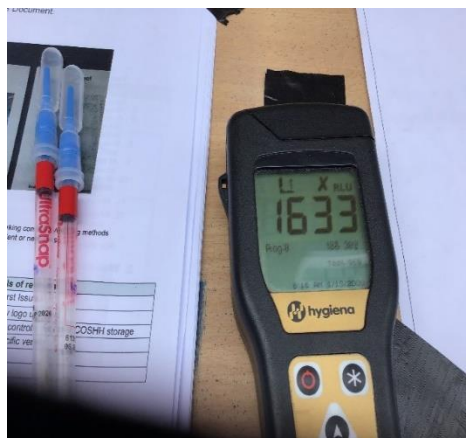
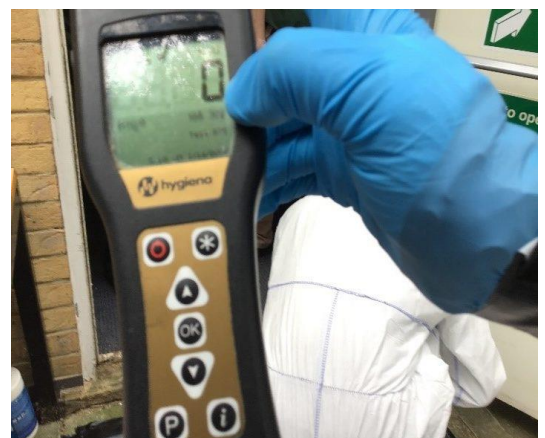
Our team recorded extremely poor Actual Relative Light results of 1,832 and 1,633 ARLs in high contact areas of contamination, and readings of 627 RLU's in corridor areas of the hospital. Following the decontamination of the ward areas, the Ideal Response team re-tested the areas and achieved an outstanding result of zero RLU's, making the area safe for patients to return.

The first reading of 1,832 RLU's was effectively reduced to zero through our comprehensive decontamination program.

We use hygiene luminometers (in conjunction with ATP swabs) to take bioluminescence measurements in Relative Light Units (RLUs). This allows us to rapidly assess the level of cleanliness of environmental surfaces in healthcare and other settings. Our goal is always to reduce RLUs to below 150-200 – and we look to reduce levels below 50 RLUs. In this case our 3-stage process reduced RLUs to zero.
