Fire Restoration in Student Accommodation

CASE STUDY

MIDDLESEX UNIVERSITY – PLATT HALLS OF RESIDENCE

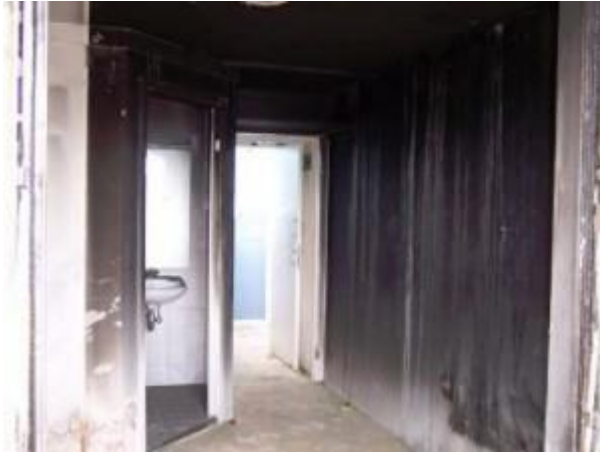
Most of the rear windows had exploded under the extreme temperature allowing the fire to take a hold of some third-floor rooms. The flames caught the woodwork under the eaves and spread into the loft space, destroying all the wooden joists, causing the roof to collapse. The fire fighters pumped thousands of gallons of water into the buildings to protect them, although this water protection saturated the walls, floors, and ceilings on every level.

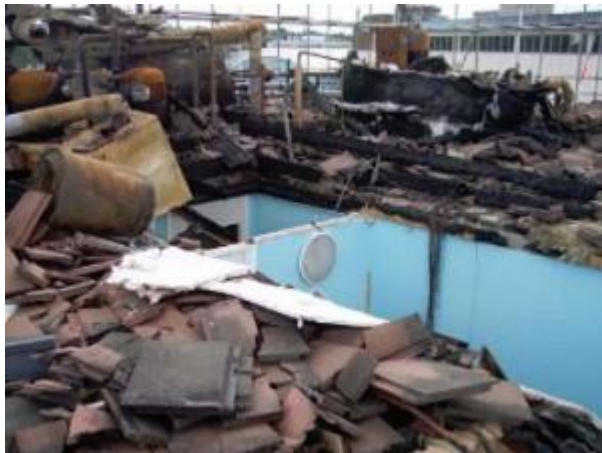
The kitchens in each flat were constructed from chipboard which absorbed massive quantities of water, causing severe swelling, fitted wardrobes and cupboards in the student rooms suffered a similar fate rendering them beyond salvage. Fire damage repairs were required as soot from the fire was washed in and contaminated the fabrics and furnishings within each of the areas.

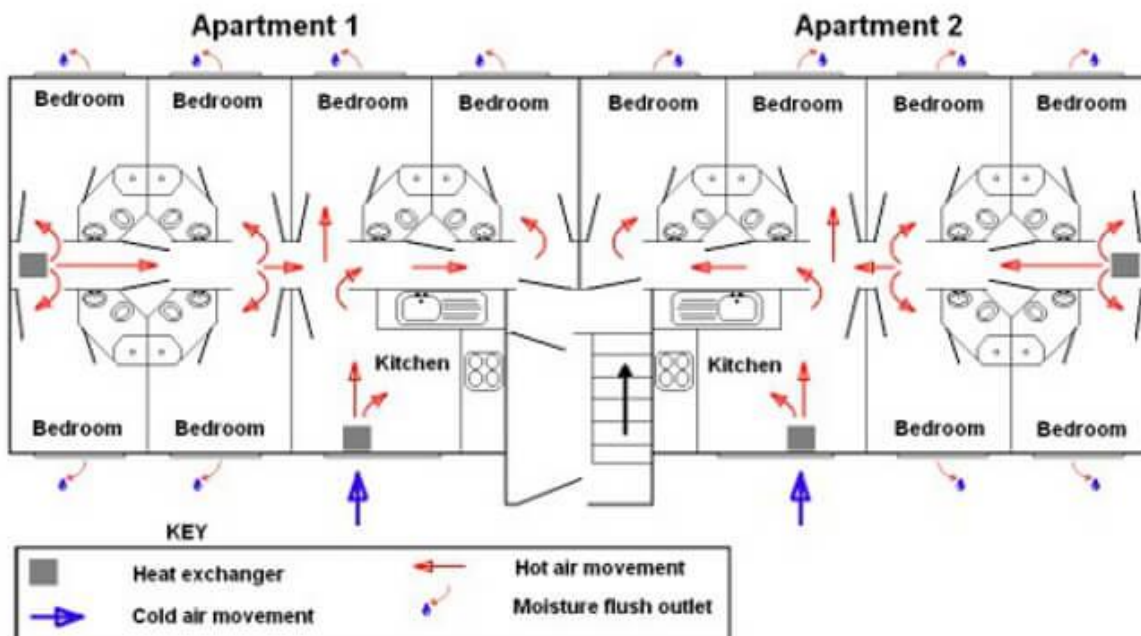
The floor plan of one block showing the positioning of the heat exchangers and the air movement, each apartment on all floors in each block are identical.

Each exchanger generates 1200 m³ of hot dry air every hour, of the two exchangers per apartment; the one sited in the kitchen window provided the positive pressure. It drives 1200 m³ of hot dry air into the apartment and insures that 1200 m³ of humid air, leaves. The other exchanger positioned at the end of the corridor re-heats and re-circulates the air.

The “pressured chamber” system was used with two hydronic heaters; each one containing; one water heater and six heat exchangers. Two heat exchangers were positioned in each apartment (as shown on the floor plan) allowing the two machines to dry six apartments at the same time. A heat exchanger was placed in the kitchen window to create heat and positive pressure and the other, at the far end of the corridor to generate heat only. All broken windows were temporarily repaired then all the windows were slightly vented to allow the positive pressure to escape.

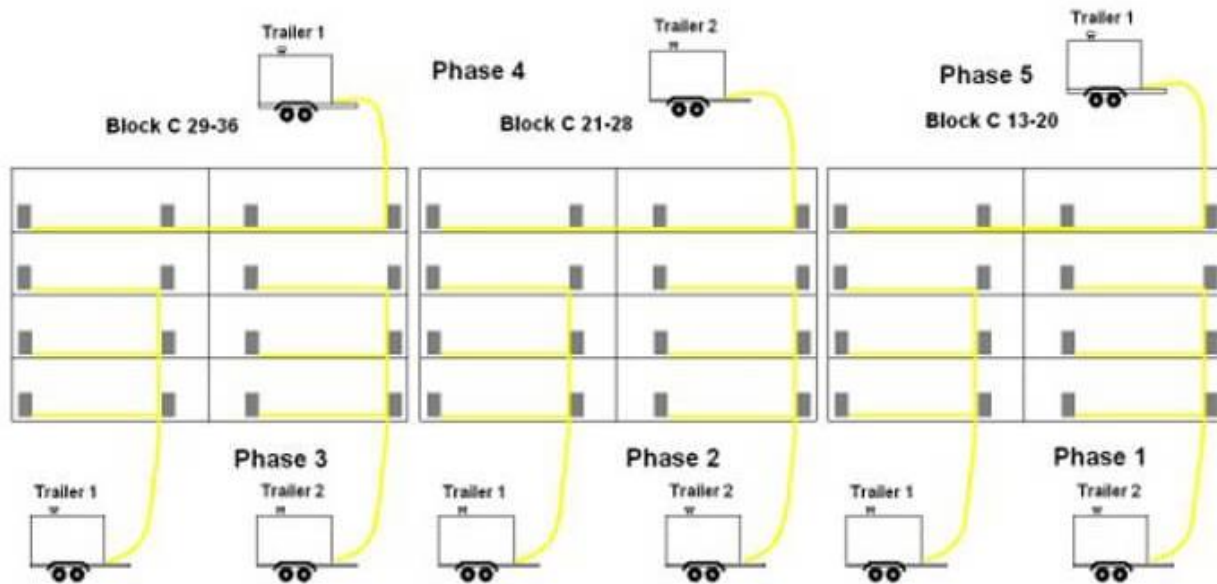
Given the apartment volume as 275 m³, the air was replenished 4.3 times every hour using this drying method, each phase was completed in just 7 days. The whole accommodation project was successfully dried in 35 days. A total of 168 rooms and been recovered in a record time. After the roof had been reinstated and the interior had been cleaned and re-decorated, the students were able to move back in.
