Edenbridge, Kent, United Kingdom

## Graffiti Removal in London

CASE STUDY

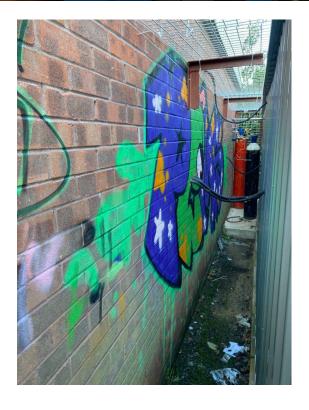
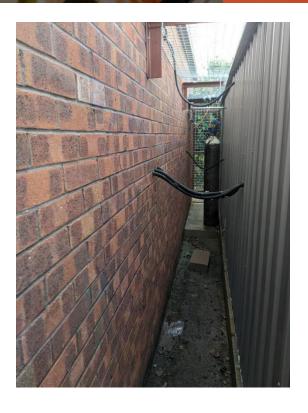
For jobs like this, I feel that it is better to let the pictures do the talking. As you will see from the before and after photos, not a trace of the graffiti was left on the property, as it was restored to its former appearance - all with minimal disruption to the work in the warehouse.

The graffiti removal in Sevenoaks had been a complete success.

Onto the graffiti removal itself: we began by applying a 2-3mm coat of paint softener, which worked to break down the paint. This was left overnight to get to work. Then, the real business started as we deployed our DOFF system.

This is a steam-based stone cleaning system that is unlike any other steam system in the world. It can reach temperatures of up to 150°C at the nozzle end which can, along with the pressure, be varied by the operator depending on the conditions. The combination of high temperatures and high pressure delivers a gentle, but highly effective clean. Crucially, the surface is not saturated with water, so it has a very quick drying time.
