## Mould Remediation Norfolk

CASE STUDY

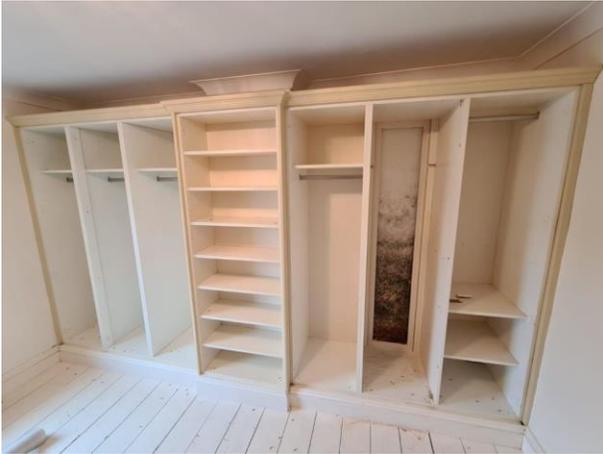
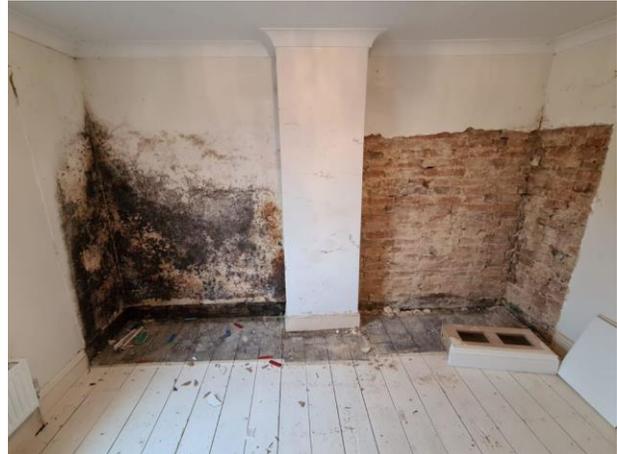
With the back wall exposed, it was clear that the extent of the mould damage was well beyond superficial surface growth and was present in the whole structure of the wall and plaster. Our trained team therefore advised the client that the best plan of action was to remove the plaster from the wall and treat the brick directly. This would get to the core of the problem to ensure complete elimination of the mould and avoid it coming back, aided by the fact that there was now better air circulation in the room.

The team used a hammer drill to chip away the infected plaster on the walls, and strip the wall back to brick. Once the plaster had been removed, we treated the brick for mould using a broad-spectrum biocide solution. This treatment was applied not only where mould was in evidence but on every exposed brick to ensure that mould would not return and give our customer peace of mind. We continued with our 4-stage mould remediation process, which concluded with Ultra Low Volume (ULV) fogging of the bedroom to eliminate any airborne mould particles.
