St Paul's Cathedral, Graffiti Removal in London

CASE STUDY

Central London, United Kingdom

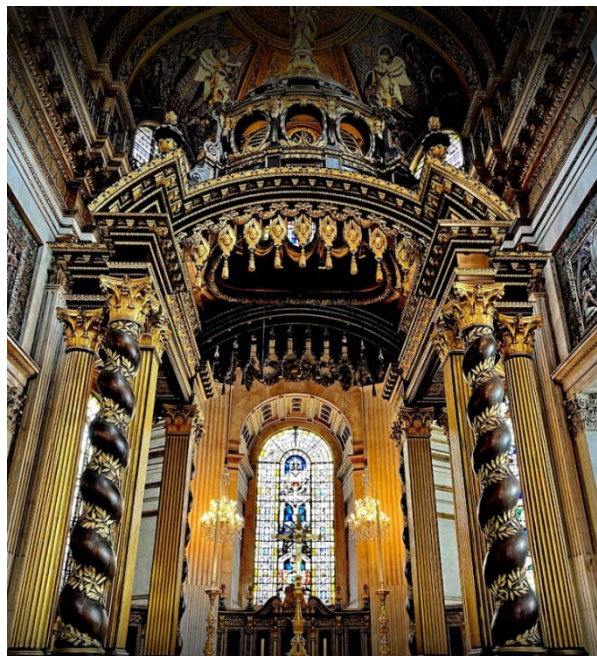
When the Clerk of the Works of St Paul's Cathedral was alerted to an 'extensive' graffiti attack on the building recently, they knew that they needed to act quickly. Their first job was to call the police – graffiti is, of course, an offence and the authorities had to be alerted. The Police took the forensic evidence that they needed from the scene.

With that in mind, our team was at the scene within two hours of the call from the Clerk of the Works, much to their delight. We were shown to the areas that needed our attention so that we could see the extent of the damage. As you can see from the photos, there was a lot of work that needed to be done.

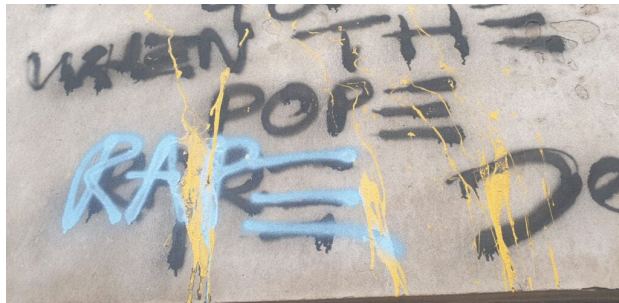
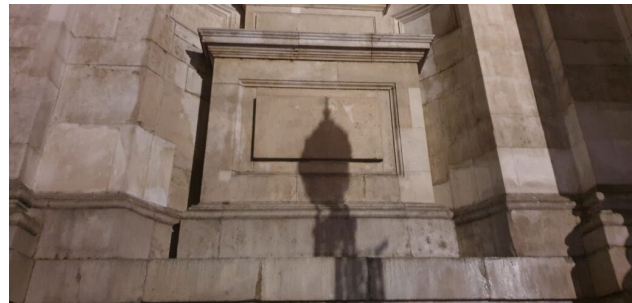
In order to remove every trace of graffiti, we applied paint remover by hand to small areas of more stubborn paint that had been splashed up the exterior walls. Again, the scaffolding came in handy here.

With jobs like this, it really helps to let the pictures do the talking. As you can see from the before and after photos, after we had completed the job, there was no trace of the graffiti at all. Our client was clearly impressed:

Now it was time to utilise our industry leading DOFF Steam Cleaning system. We chose this system because of the delicate nature of this, nearly 350-year-old, building. The DOFF system relies purely upon water – no chemicals at all – albeit at high temperatures (up to 150°C), which makes it perfect when you want to ensure that you aren't causing any damage to the building.

To reach the affected areas that were high up, the Cathedral kindly provided us with some scaffolding, which made our job much easier. We were then able to use our specialist equipment at full capacity.
